Economic Ecology

American Planning Association – PA Chapter Spring Forum April 14, 2015 Mark Gutshall, Founder and Vice President

Principles of Economic Ecology: Emphasis on the Floodplain

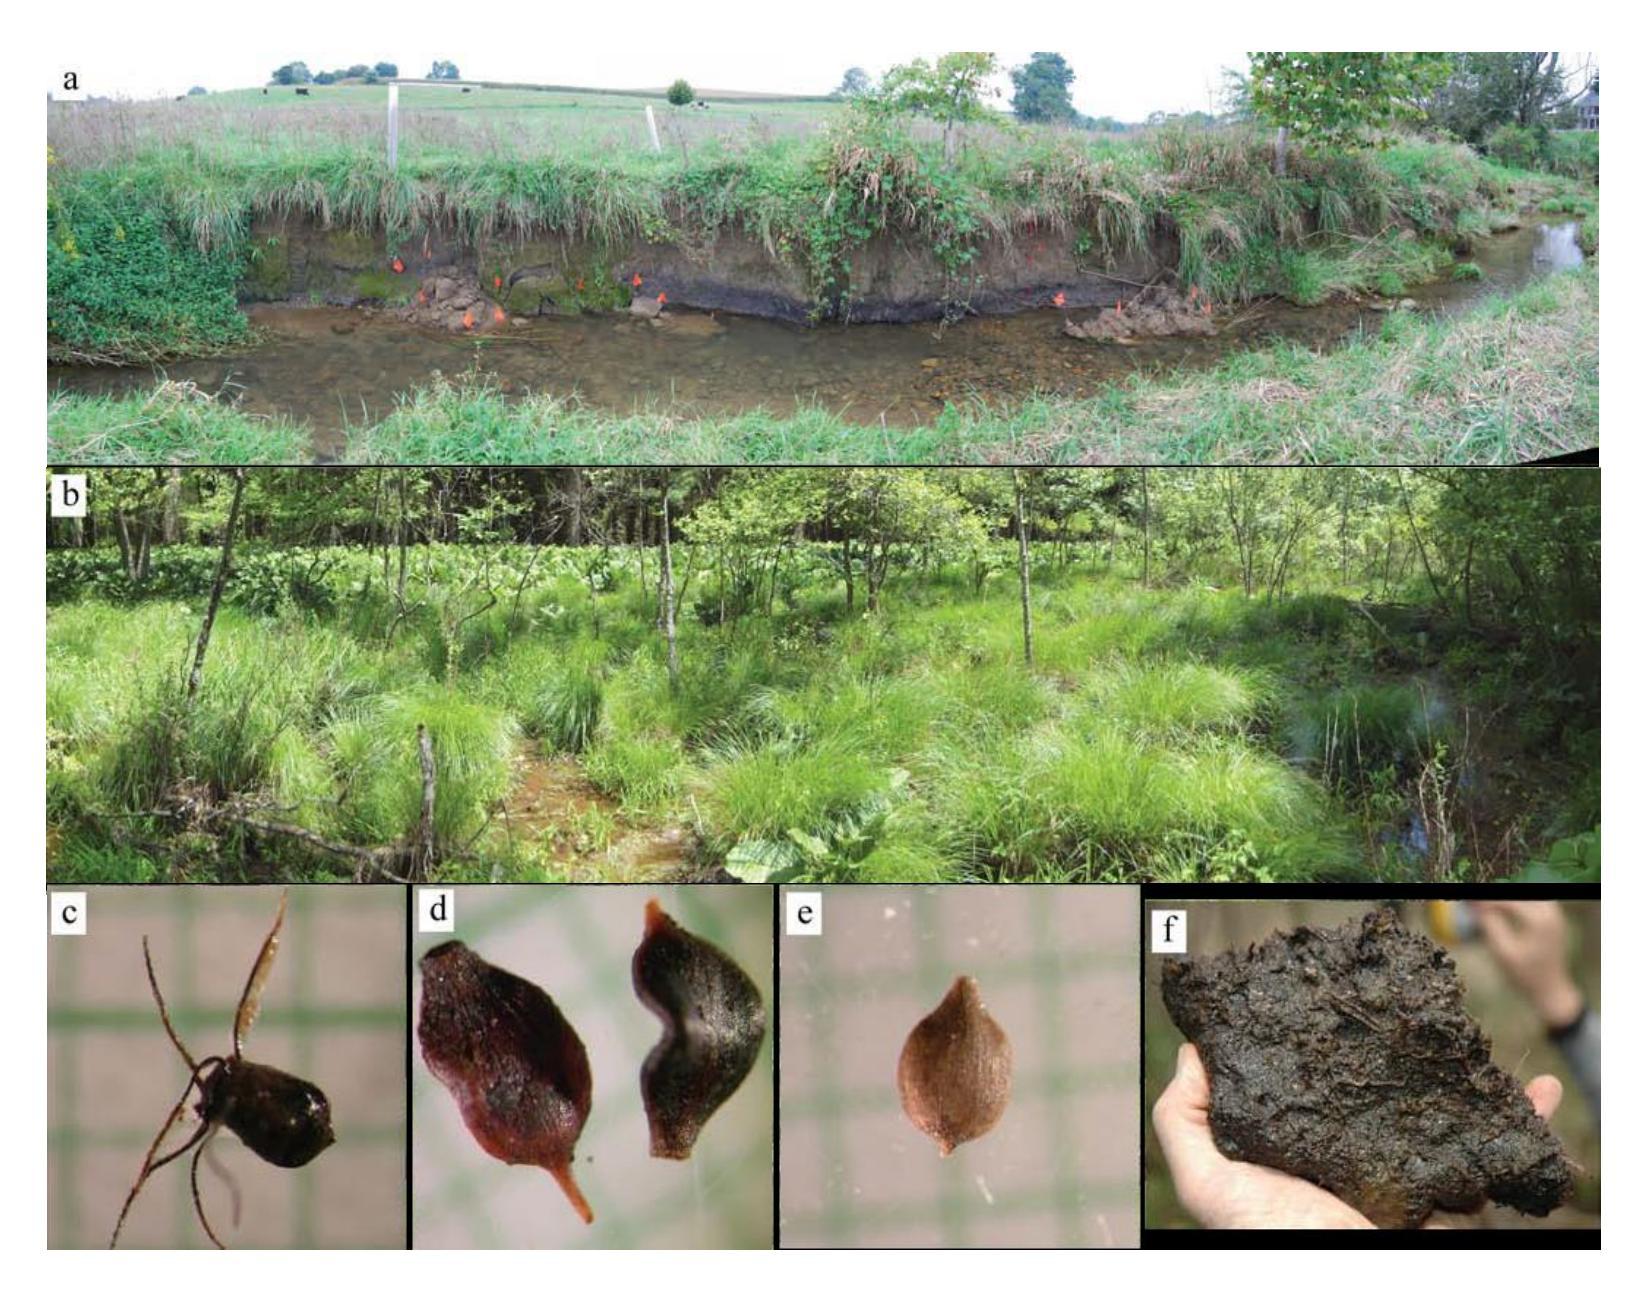
Magnetic Susceptibility

Hydric Soil ~ 12-18 inches

Basal Gravels 6-20 inch

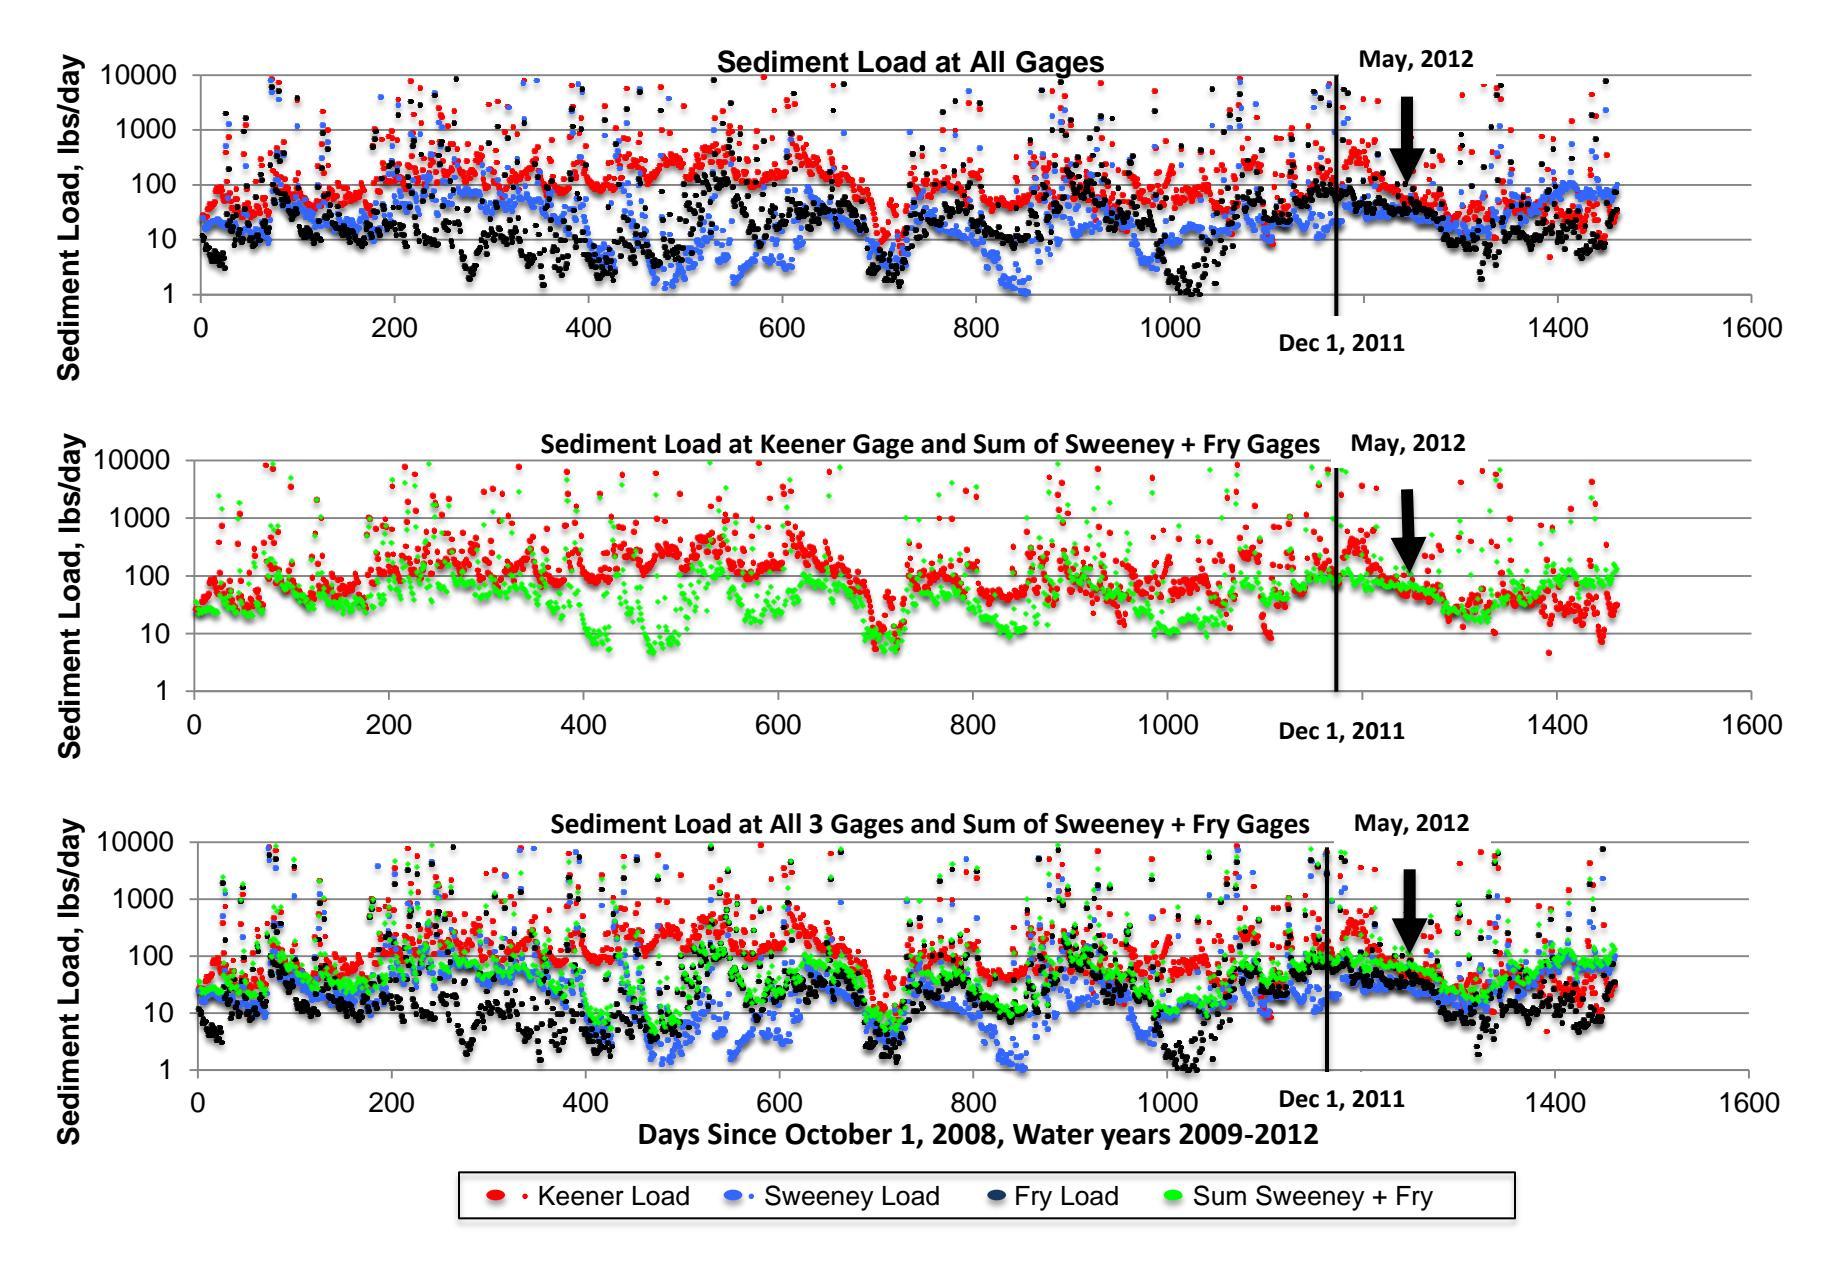
Daily suspended sediment loads from October 1, 2008, to September 30, 2012. Black line is end of construction, Dec 1, 2011. Black arrow is time of marked reduction in sediment load from restoration reach (May, 2012).

- Sediment loading decreased 218 tons per year to 109 tons per year (94 tons/year was contributed to bank erosion prior to restoration)
- The source of the load of sediment from bank erosion within the restored reach no longer exists
- Post-restoration: increase in number of days the observed amount of sediment entering reach is greater than that measured downstream – deposition

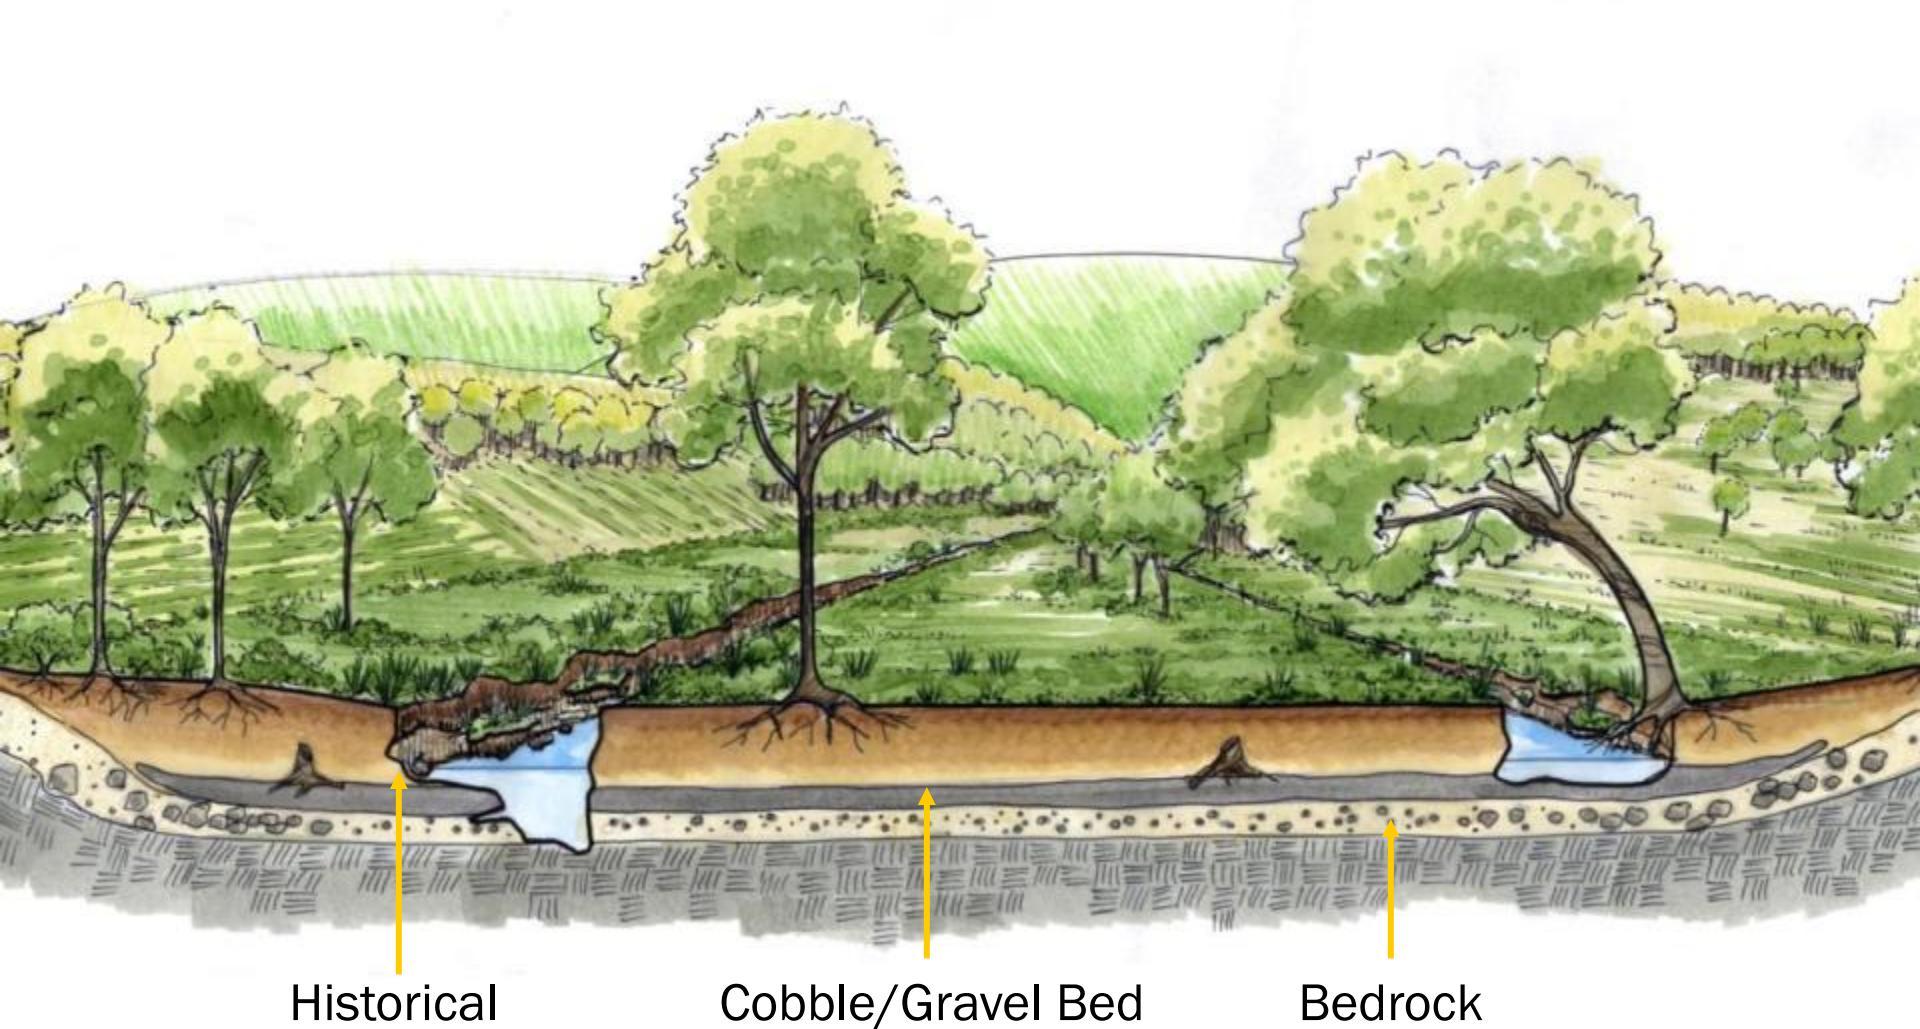
Existing Conditions

Floodplain Soils

Historical Floodplain

Roots extendFloodplain Soils -Colto groundwaterShallow, Peaty,(Organic, & Porous(

Cobble/Gravel Bed Bedrock (Groundwater)

Legacy sediment removed = 21,704 cy (~21,955 tons) Total phosphorus removed = ~50,498Ibs (2.3 Ibs-P/ton) Total nitrogen removed = ~63,669 Ibs (2.9 Ibs-N/ton) Reduction in sediment flux out of site = 109 tons/year

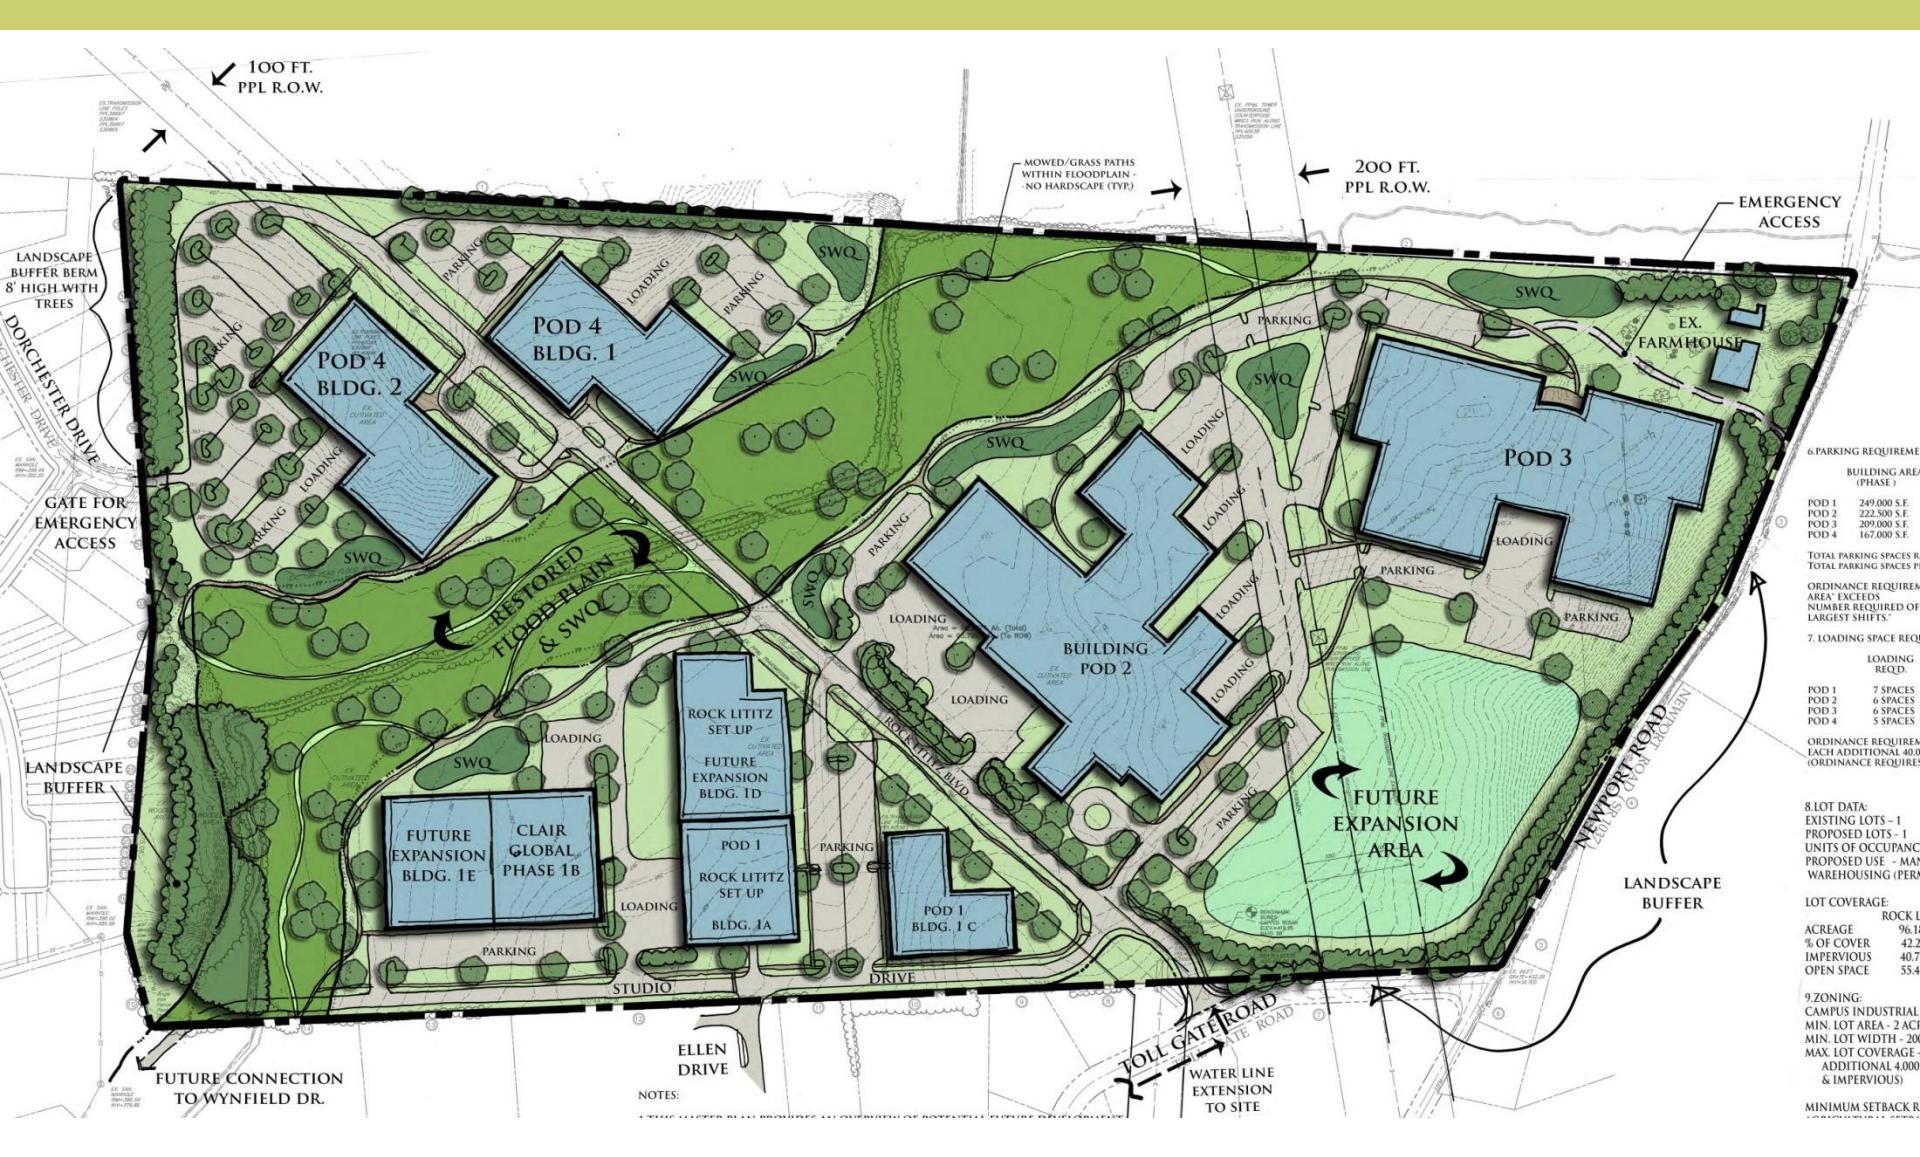
Rock Lititz- Masterplan

Stormwater Management Facility (site & regional) - 17 acres

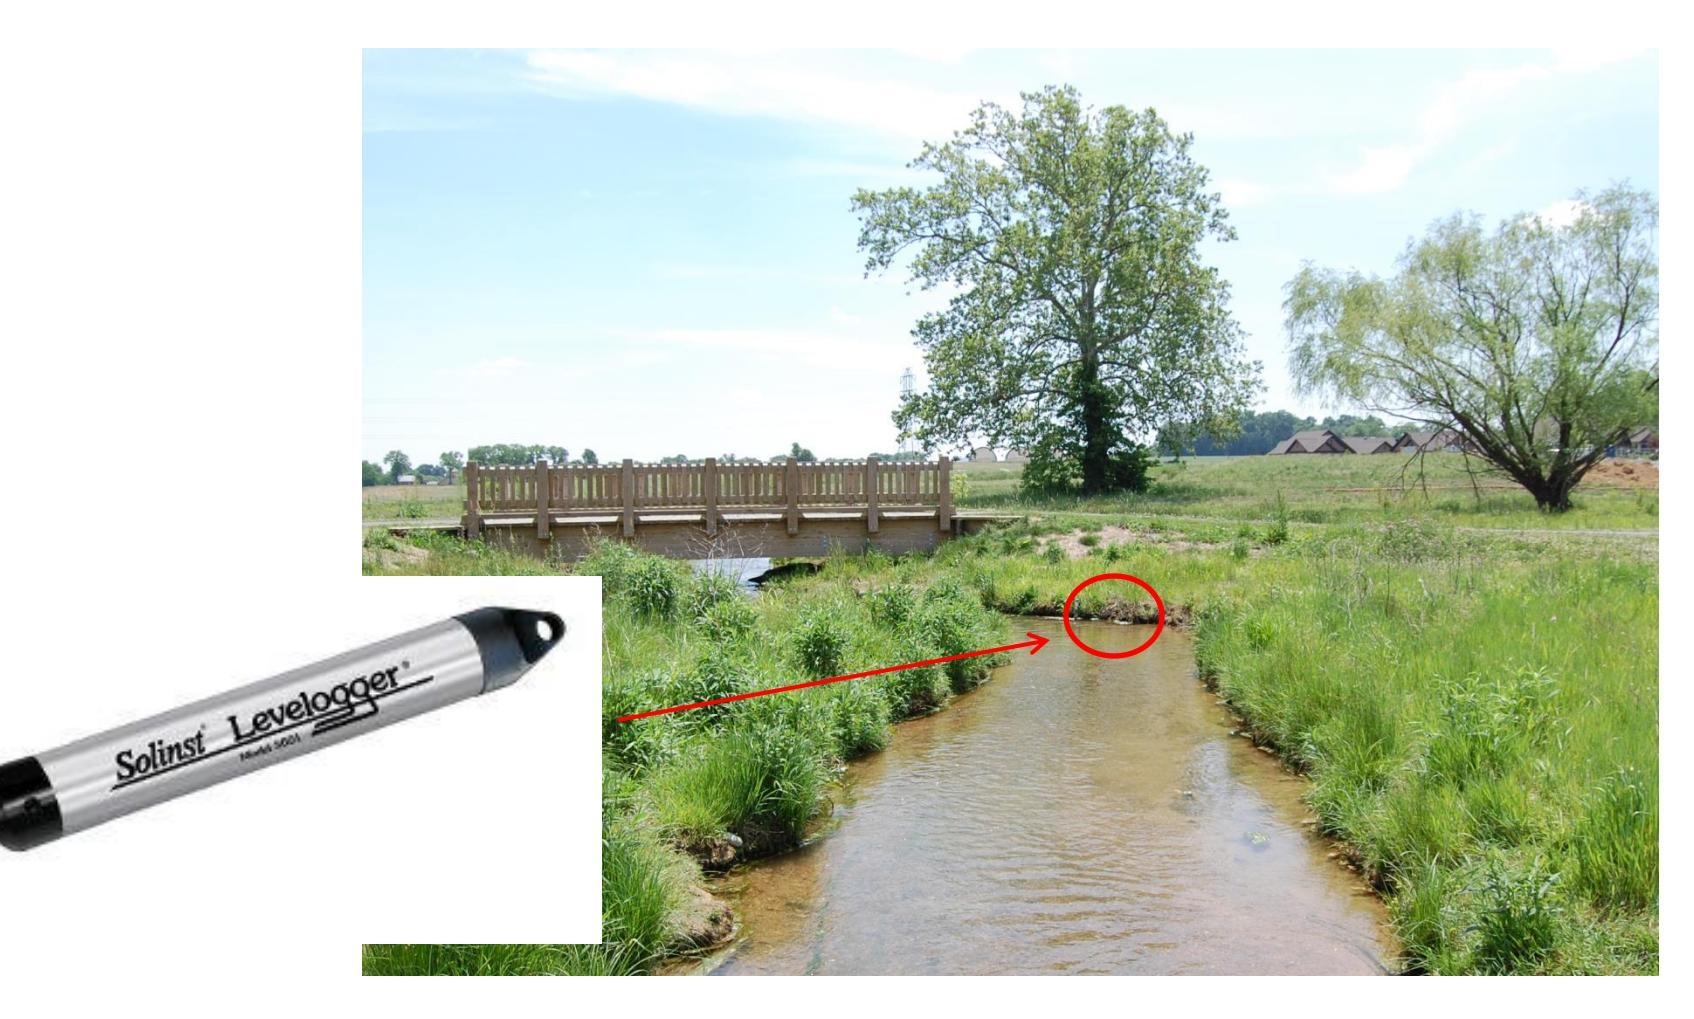
Data Monitoring

A Pressure Transducer called a Levelogger is used as a cost-effective solution for continuously measuring water level and temperature.

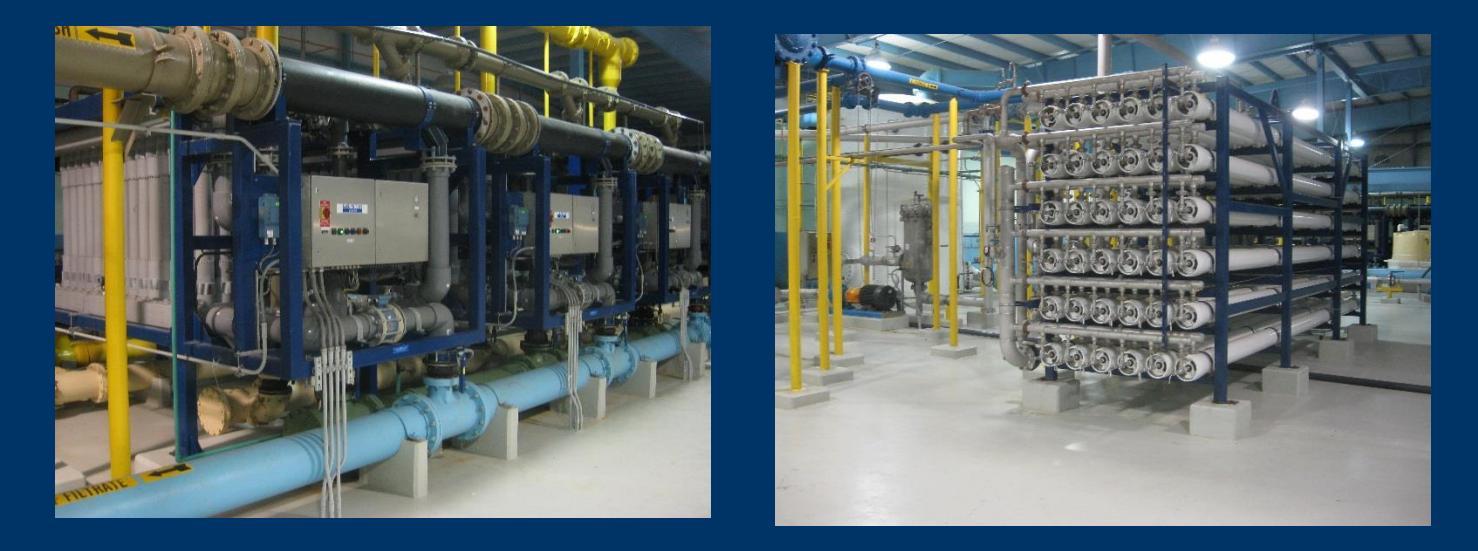
UAJA Beneficial Reuse Project

Wastewater purified through Micro-filtration and Reverse Osmosis used to augment Slab Cabin Run and recharge the drinking water aquifer

- Up to 3 million gallons per day
- Moves water seven miles upstream
- Provide energy benefit to region
- Restore Slab Cabin Run to historical conditions
